Please find attached our Liner Damage Assessment, Repair and CQA Report for recent repairs on the MSW Cell E6 Sideslope Liner. Also attached is a figure showing the recommended MSW filling area in Cell E6.

Subject: Liner Damage Assessment, Repair, and Construction Quality Assurance Report
for Cell E6 Sideslope, Waimanalo Gulch Sanitary Landfill, Kapolei, HI

Figure 1
MSW Cell E6 Sideslope
Liner Damage Areas

Waste Management of Hawaii
Waimanalo Gulch Sanitary Landfill
Kapolei, Oahu, Hawaii

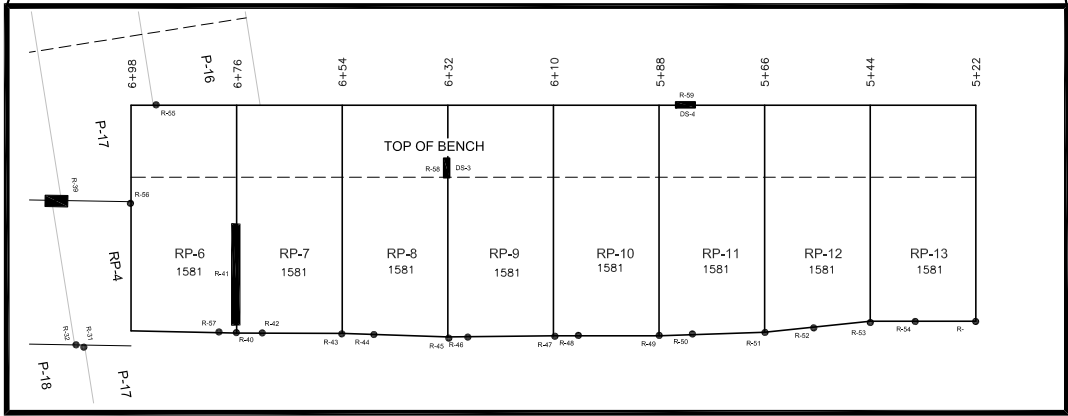
Figure 4
Northern Repair Area,
60-mil Repair Locations

- R-1 LINER REPAIR
- RP-9 1581 LINER REPAIR PANEL ROLL NUMBER
- CREST OF SLOPE

NOTES:
1) THIS IS A GRAPHICAL REPRESENTATION OF LINER INSTALLATION AND REPAIRS PREPARED FROM FIELD MEASUREMENTS AND OBSERVATIONS.
2) NEW GCL WAS PLACED BENEATH THE 60-MIL HDPE GEOMEMBRANE REPAIR PANELS.
